TECHNICAL INSPECTION REPORT

⑥ OPERATION CROSSROADS.
U.S.S. SKIPJACK (SS 184).

TEST BAKER.

VOLUME 1

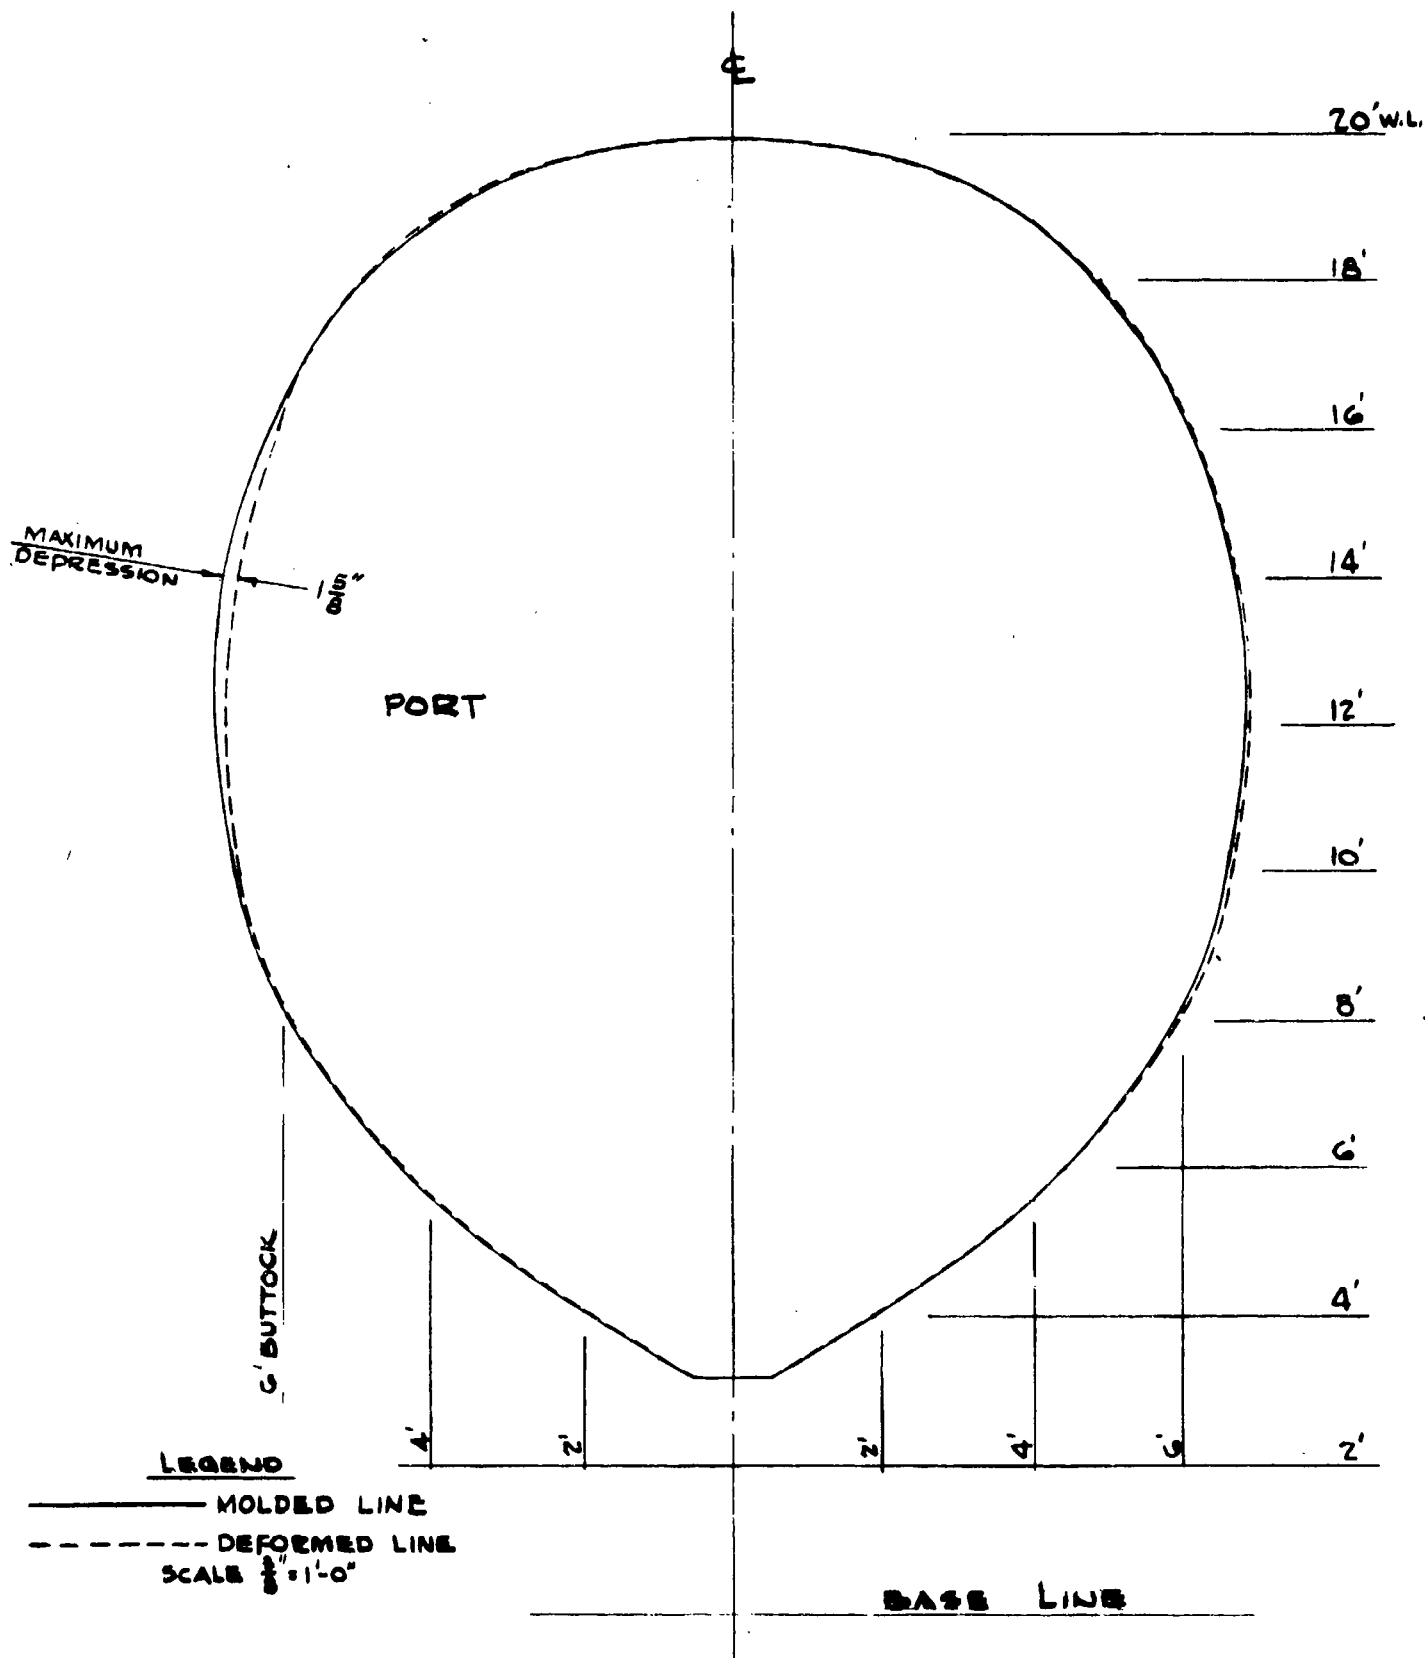
FRAME #23
 PAGE 34 OF 141 U.S.S. SKIPJACK (SS-184)
 7123

30 - 32 port, 156 - 158 port and 176 - 184 on both sides of the keel. The existing molded lines of the distorted frames in the most severely damage areas were determined and compared with the original molded lines. The results are plotted on pages 30 to 56 of this Volume.
